Test Report

Nr. 14-000559-PR02

Object Component test with frame screws for fastening a plastic frame of a window in the structure

Product Window frame screw FFS bzw. or window frame screw FFSZ Ø 7.5 mm, dowel-less frame screw, Plastic windows made of PVC multi-chamber profiles with Steel reinforcement, vertically perforated brick masonry of the type ISO - Plan plus 0.11

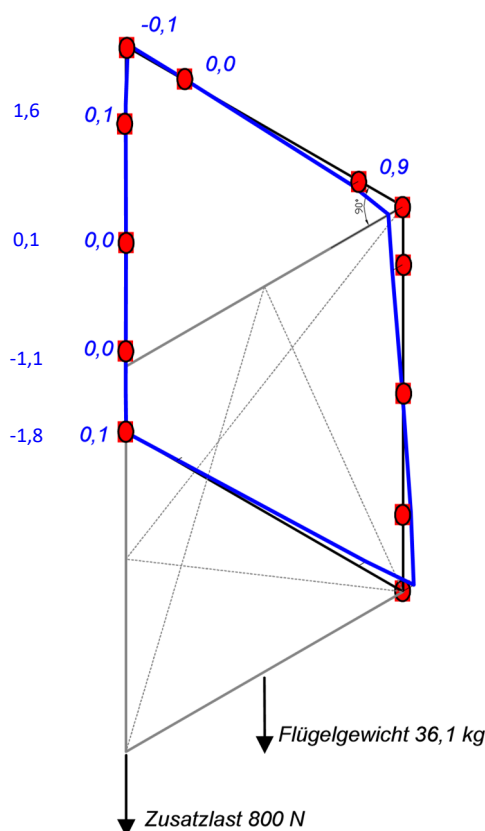
The sash with a dead weight of 36.1 kg was additionally loaded one after the other with additional loads of 200 N, 400 N, 600 N and 800 N (according to class 4 according to DIN EN 13115) on the closing side when it was opened approx. 90°. After a loading time of 5 minutes in each case, the additional load was removed. A waiting time of 2 minutes was observed between the load levels. After the loading was completed, the window was checked for movement. The occurred maximum of displacement is described in Fig. 12.

There were no permanent deformations or visible changes at the fastening points (change in position at the measuring points after loading ≤ 0.5 mm). The window could be operated without any problems after the load. The window was adequately anchored in the structure.

Fig. 12 Displacements [mm] of Frame with the sash open (dead weight 36.1 kg) and an additional load of 800 N.

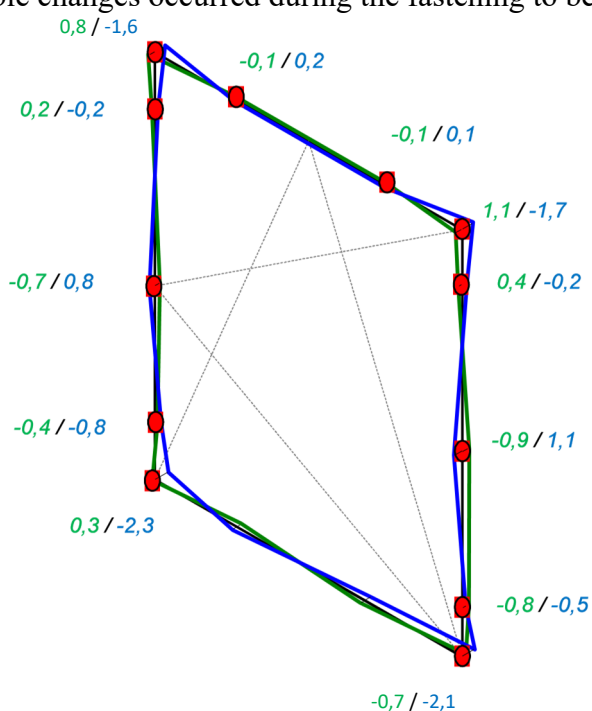
On the outside of the test specimen, a temperature change between $(+ 60 \pm 3) ^\circ \text{C}$ and $(-15 \pm 3) ^\circ \text{C}$ outside air temperature was generated by means of a climatic chamber and passed through 10 times. The maximum deformations that have occurred are shown in Figure 13. The deformations of the window under thermal load were reversible (change of position at the measuring points after loading $\leq 0.2 \text{ mm}$). Due to the influences of the lower fastenings in combination with the support block for load transfer below, a change in position of ≥ 0 occurred at fastening point 7, see Figure 8, 5 mm after the load. However, this change in position did not affect the functionality of the window or the fastening). No permanent deformations or visible changes occurred during the fastening to be assessed

Fig. 13 Maximum deformation [mm] under thermal cycling between $+ 60 ^\circ \text{C}$ (green) and $- 15 ^\circ \text{C}$ (blue).

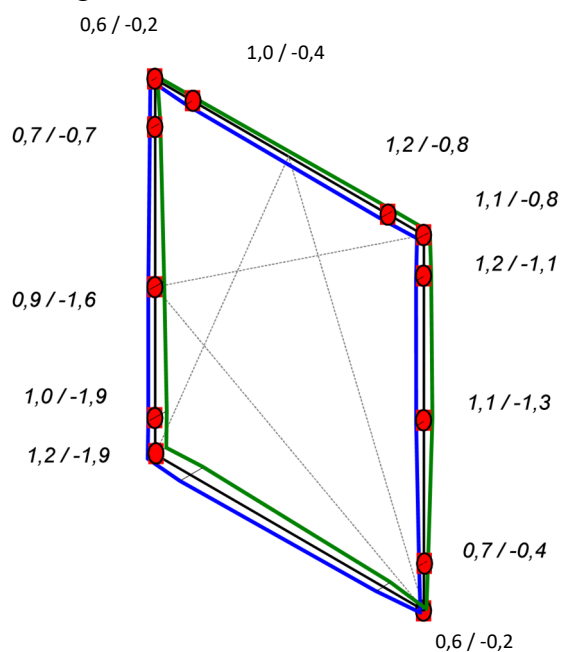
The movements and deformations of the window were reversible (change in position at the measuring points after loading ≤ 0.2 mm). There were no permanent deformations or visible changes.

Compared to the first alternating pressure-suction load, no significant changes were found at the attachment points with regard to the maximum deformations that had occurred.

Fig. 14 Deformation [mm] of the window frame with alternating pressure-suction loads of + 800 Pa (blue) and - 800 Pa (green).

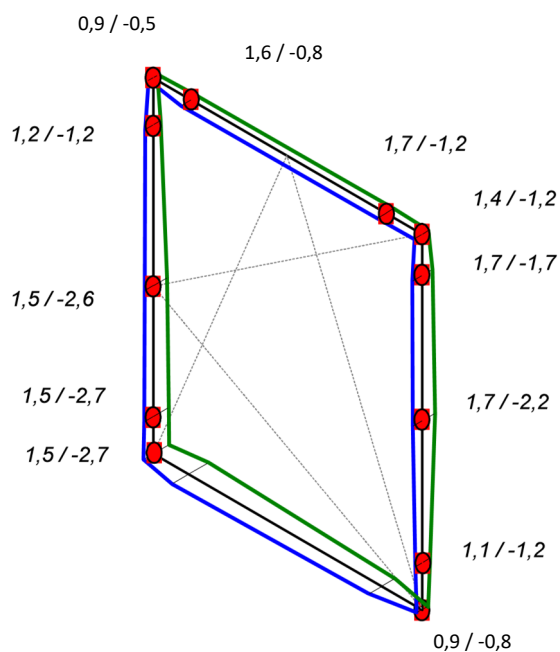
The movements that occurred were reversible (change in position at the measuring points after loading ≤ 0.2 mm). There were no permanent deformations or visible changes.

Compared to the first static pressure load, there were no changes to the maximum deformations at the attachment points.

Fig. 15 Deformation [mm] of the window frame with static pressure load of + 1600 Pa (blue) and - 1600 Pa (green).

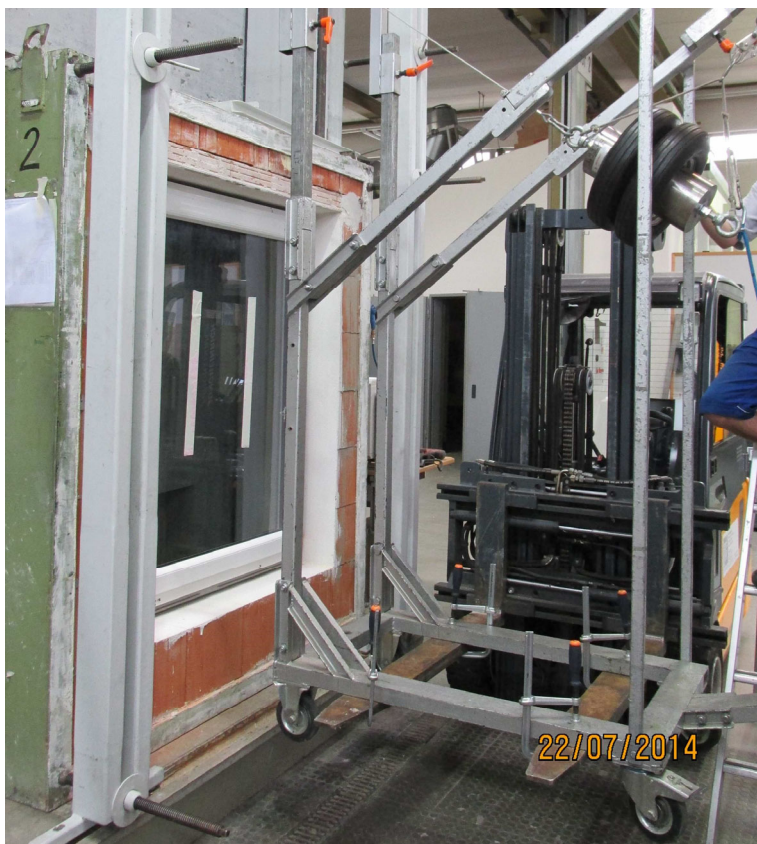
The window remained adequately anchored in the structure after the impact. The frame screws were partially permanently deformed by the impact load. No loosening in the masonry was found.

Fig. 16 Test setup pendulum impact

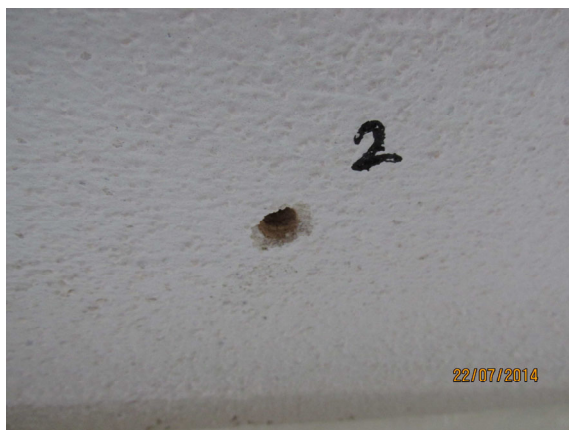
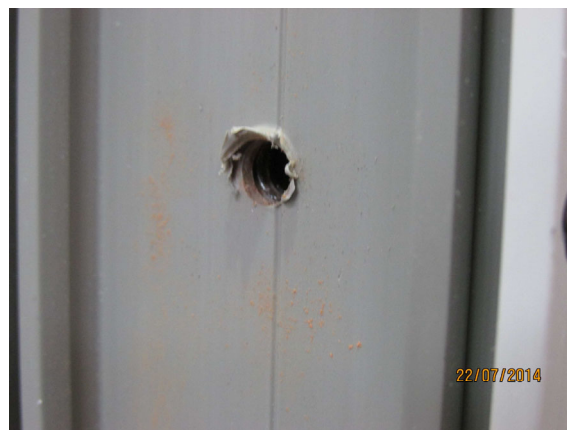
Fig. 17 and 18

All frame screws had a firm fit in the masonry. The drill holes in the masonry and in the frame profile showed no changes (widening or breakouts) (for example, Figures 17 and 18). Figures 19 to 22 show the condition of the frame bolts with some slight deformations due to the impact loads.

Condition of the holes in the masonry and frame profile after dismantling the frame screws.

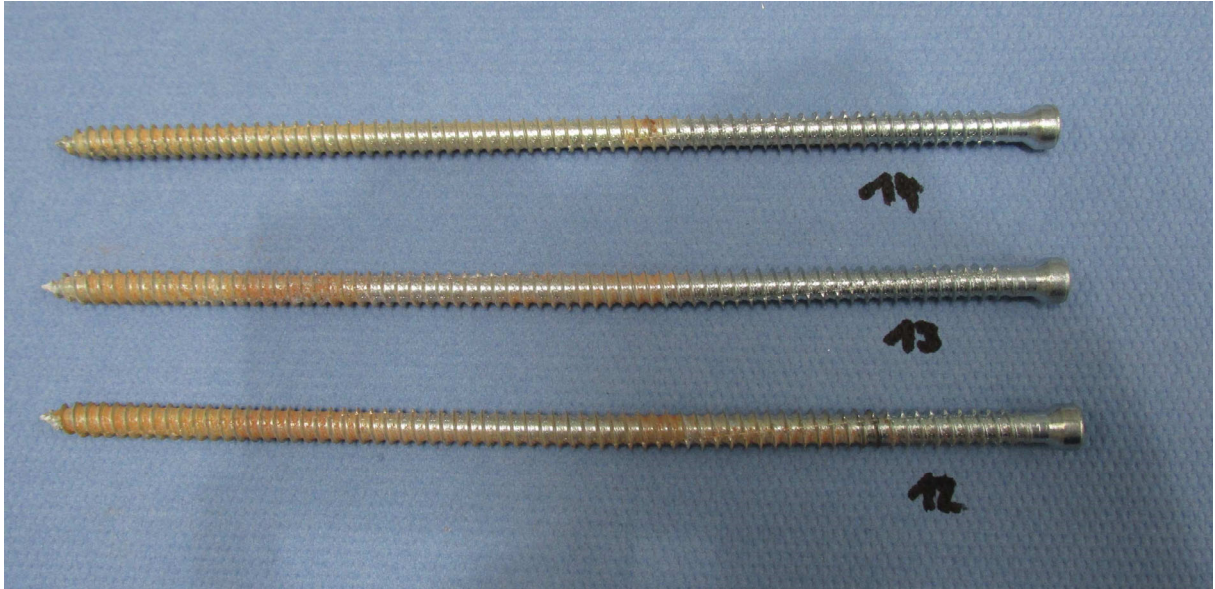
Fig.19 Condition of the window frame screws FFSZ 7.5 x 202 with some slight marks deformations dismantling

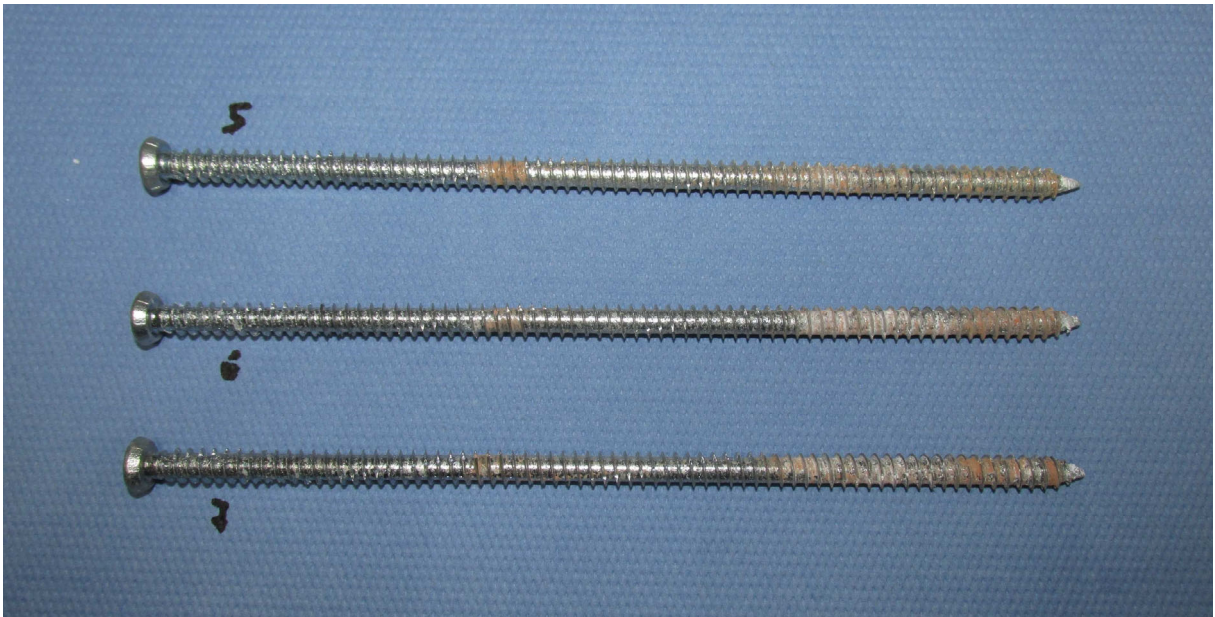
Fig. 20 Condition of the window frame screws FFS 7.5 x 202 with some slight deformations after dismantling

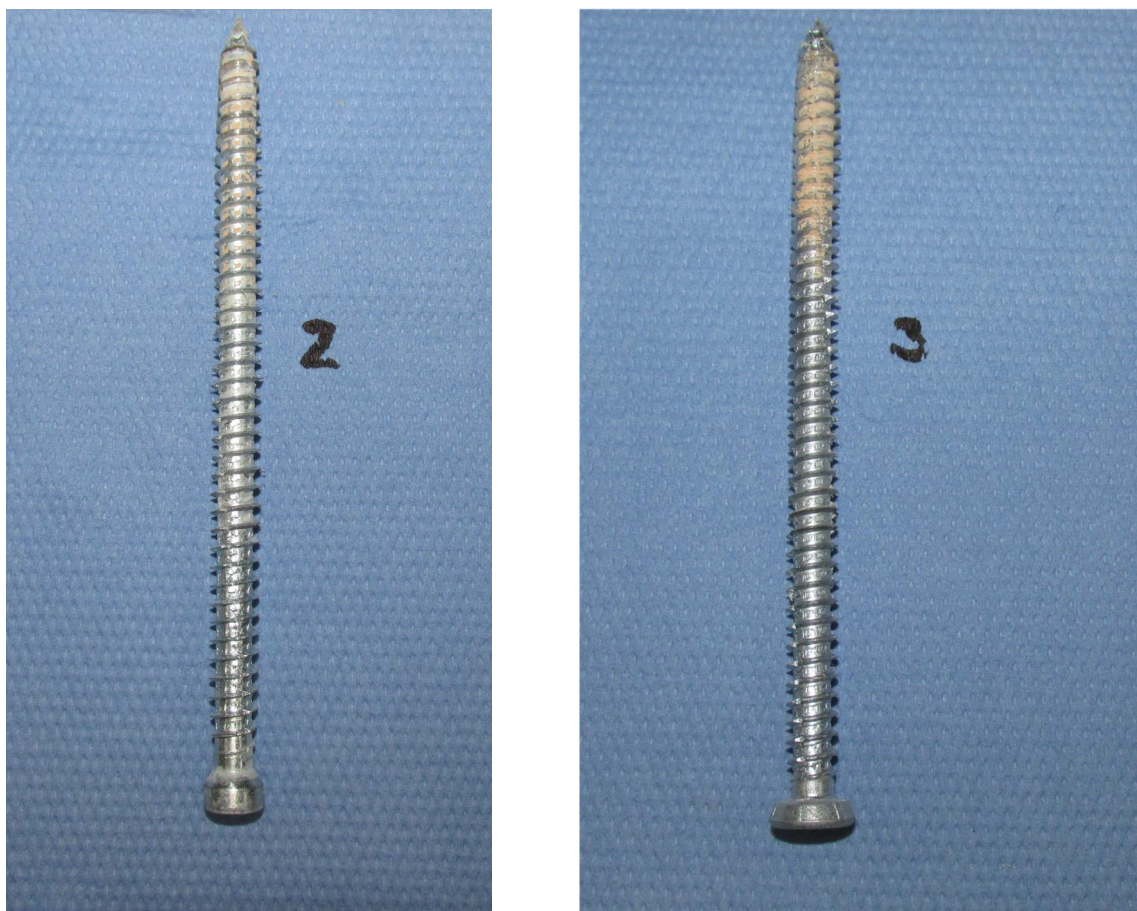
Fig. 21 and 22 Condition of the window frame screw FFSZ 7.5 x 122 and Window frame screw FFS 7.5 x 122 with partially light deformations after dismantling
